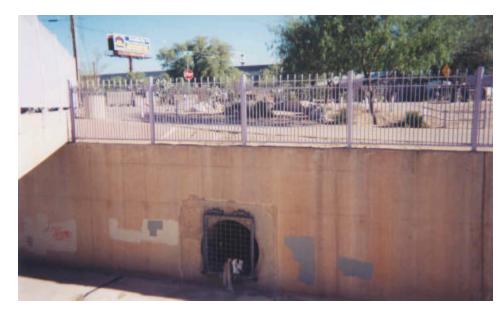
Outfall Identifier: 10-260.7

Description: 72" RCP outfall into north bank of Julian Wash at 10th Avenue south of I-10.

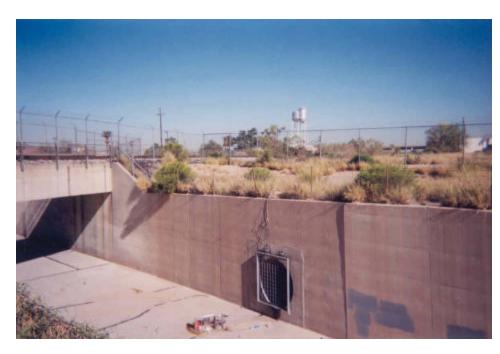
Outfall Identifier: 10-261.5

Description: 78" RCP outfall into north bank of Julian Wash west of South Park Avenue and north of Ajo Way east of railroad tracks.

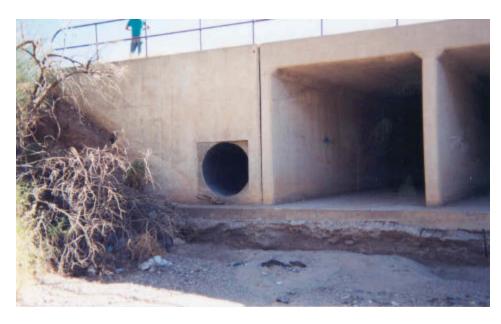
Outfall Identifier: 10-264.6

Description: 56" x 42" CMP outfall into north bank of Julian Wash south of I-10 and Palo Verde Road interchange, west side of Palo Verde and north bank of Julian Wash.

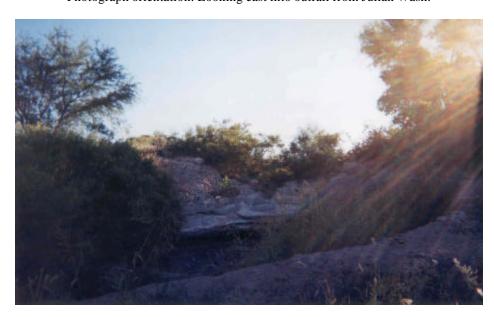
Outfall Identifier: 19-59.0

Description: 1200' S. of I-19 & Valencia Interchange – S. of Valencia & E. bank Santa Cruz River Photograph orientation: Looking east into outfall (36" CMP is now open wash into river).

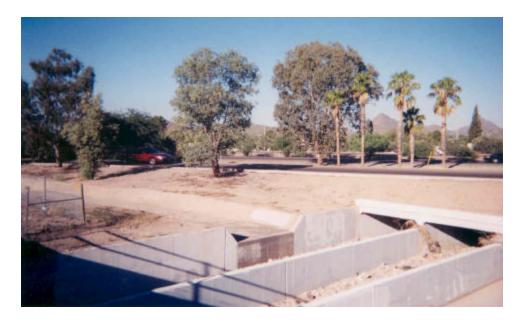
Outfall Identifier: 19-61.7

Description: Open channel outfall into Rodeo Wash south of I-10 and Ajo Way interchange at east side of I-19 and south bank of Rodeo Wash.

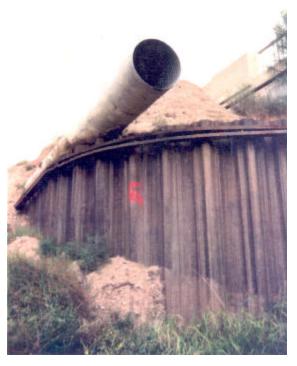
Outfall Identifier: 86-171.1

Description: 36" CMP outfall into west bank of Santa Cruz River south of Ajo Way.

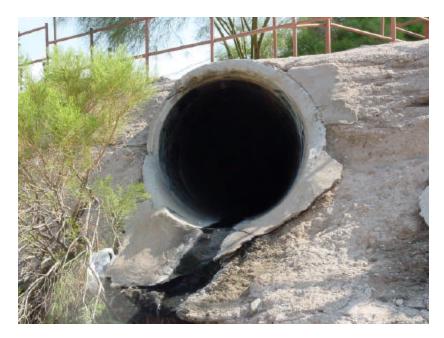
Outfall Identifier: 77-71.74

Description: 72" CMP outfall into south bank of Rillito River at east side of Oracle Road.

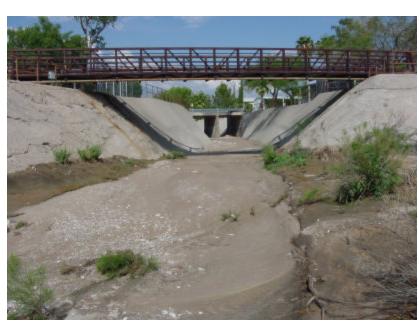
Outfall Identifier: 77-71.8

Description: Open channel outfall into north bank of Rillito River at east side of Oracle Road.

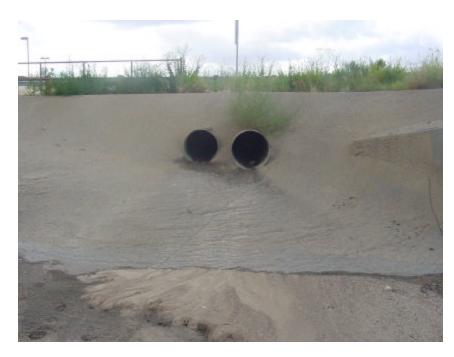
Outfall Identifier: 77-78.7

Description: 2 36" CMP (used to be 42" RCP but now 2 pipes emptying into outfall) SE quadrant of US 77 and Greenock Dr. Photograph orientation: Facing south into outfall and bank of wash.

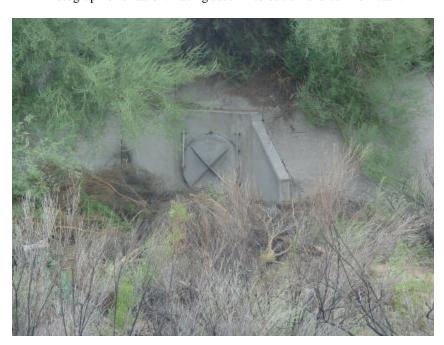
Outfall Identifier: 77-78.9

Description: 42" RCP at NE quadrant of US 77 and Greenock Dr. Photograph orientation: Facing north on east side of US 77.

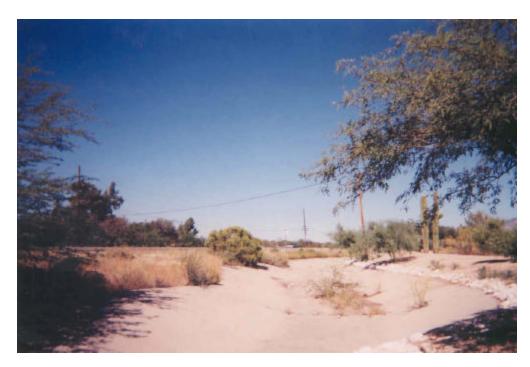
Outfall Identifier: 77-79.9

Description: Open channel outfall into tributary of Canada del Oro SE quadrant of US 77 and Hanley Blvd.

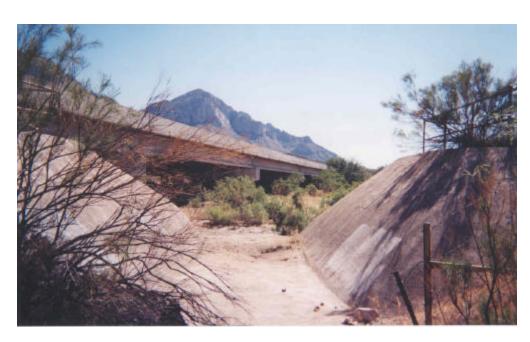
Outfall Identifier: 77-80.8

Description: Open channel outfall into tributary of Canada del Oro SE quadrant of US 77 and Canada del Oro.

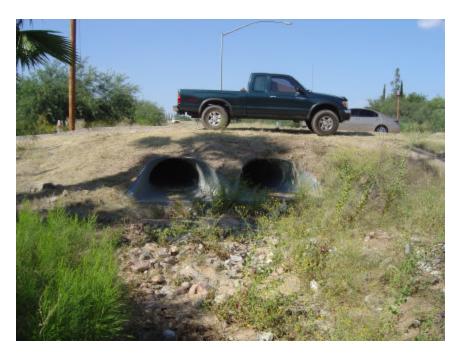
Outfall Identifier: 77-85.97

Description: 2 - 43" x 27" SD west of US 77 and north of Big Wash Tributary.

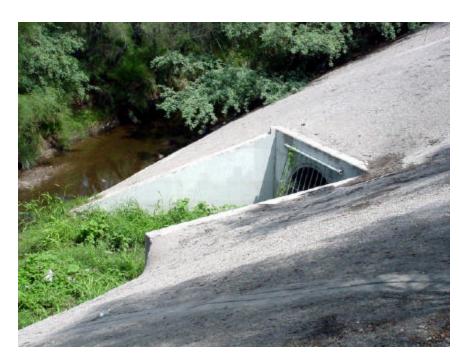
Outfall Identifier: 210-1.2

Description: 96" RCP outfall into Arroyo Chico southeast of 10th Street and 3rd Avenue intersection.

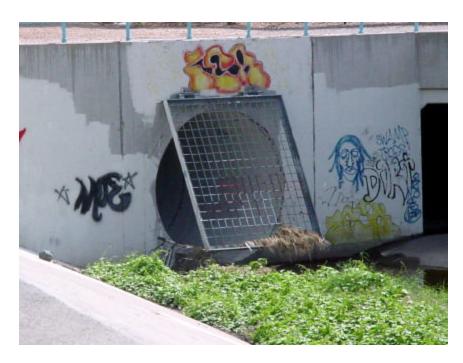
Outfall Identifier: 210-2.7

Description: 108" RCP outfall into Railroad Wash in NW quadrant at intersection of Campbell Avenue and Aviation Parkway.
